## Details on Defect Installation

### Dent and Gouge Machine Defect Fabrication

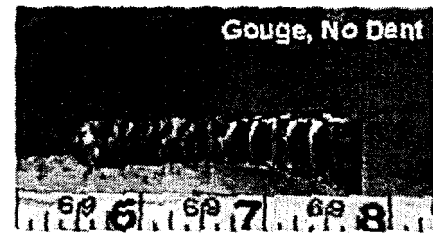
Shown at right are four defects made with the spherical indenter. Several features are obvious. First, the contact area between the ball *and* the pipe can be large, often extending several inches on *either* side of the gouge. Second, the socket for the indenter produced a circular mark on the pipe at the start of each defect (this is most clearly seen in the upper left defect). Third, there is same asymmetry to the defects, with the protruding tooth grabbing more on one side than an the other. Finally, there is evidence of slip-stick, which is discussed later.

Most of the difficulties encountered with the spherical indenter are not present in the defects made with the tooth indenter, with the exception of slip-stick. Slip-stick is a phenomena due to the effects of adhesion occurred in making some of the defects, which leads to chatter marks along the gouges. This slip-stick action occurred primarily near the ends of the defects, whereas the region between the ends was free of such chatter marks. Such chatter marks are not unusual in defects made where the damage involves sliding under significant normal load, and such an effect is compounded at

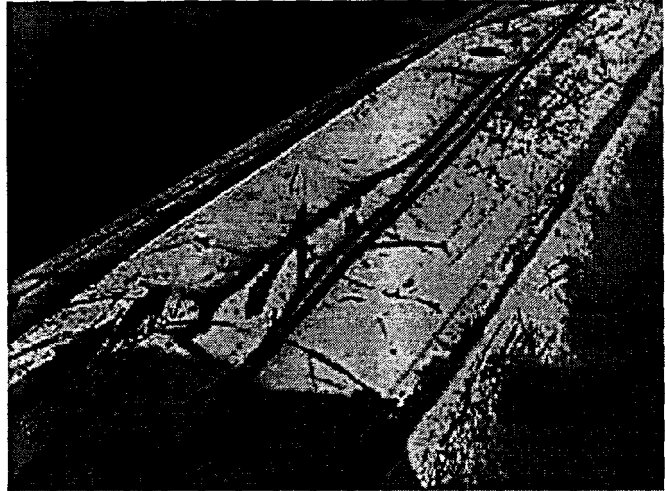
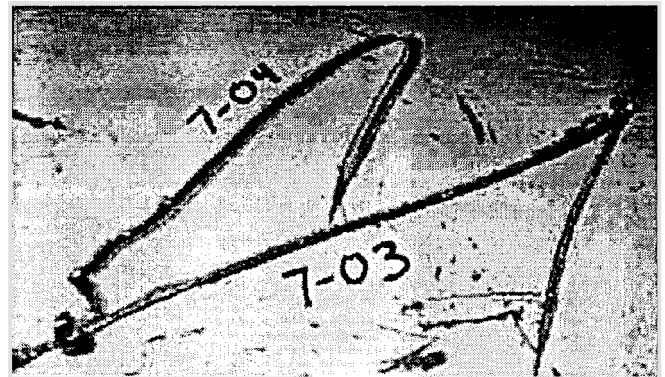
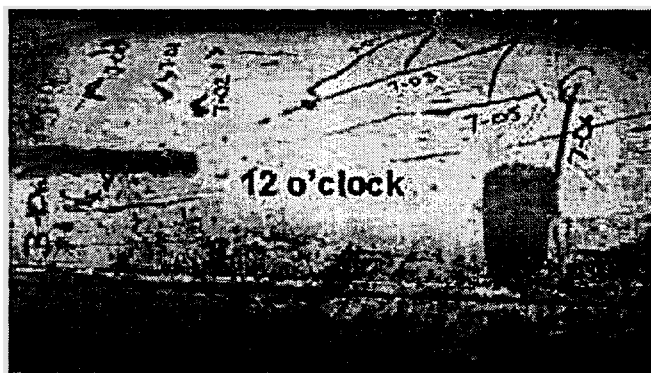
- Vertical hits on crown of pipe
- Hits and scrapes on crown of pipe
- Scrapes on crown of pipe
- Hits and scrapes on side of pipe
- Scrapes on side of pipe
- Scrape perpendicular to pipe axis.

These defects were made by striking the pipe with a rubber-tired 3000 series John Deere backhoe. Two internal pressures were used during impact, 150 psi and 250 psi.
